# **The Paddock Information Collection – The most comprehensive source of information about Paddock**

## **Understanding the water ingress problem – a discussion paper (Bill Ridgeway)**

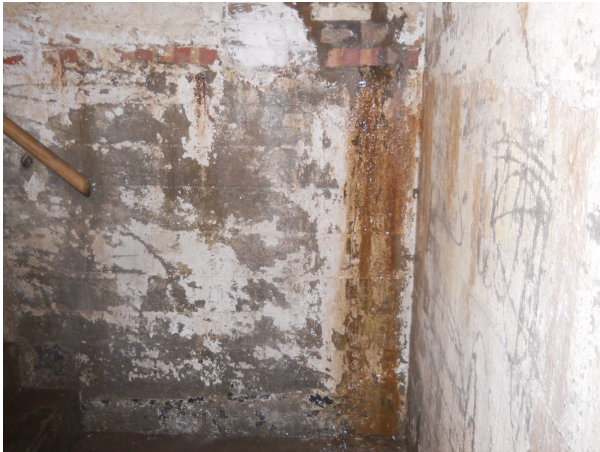
Image 1 (Photo: Bill Ridgeway)

A horizontal fault (a bad joint between concrete and brick) runs between the half-landing (on the main entrance stair well) (LRS79) (**Image 1**) to above the bottom of the stairs (LR160) (**Image 2**). There are two flows of ingressed water. One flow emerges from the wall in the half-landing and the other emerges from the wall of above the area at the bottom of the stairs. Both flows accumulate at the bottom of the staircase (LRS78) and in the small room (LR131) adjacent to and underneath the staircase and overflows the gas-tight door frame and into the gas lock (LR162). Duckboards have been placed in LR160 and LR162. Water in this area is not cleared prior to open days. I believe that water percolates through the wall into the kitchen (LR130) (**Image 3**). The point under the sink in the kitchen is directly over a conduit pipe (which originally contained a pipe for the extraction of water from the south sump). (LR028) (**Image 4**). The water flows through this, now broken, conduit and into the Sub Basement spine corridor (LR051 and LR055) (**Image 5**).

My suspicion is that the principal flow down the staircase (actually occurring all along the joint between the top of the roof of the basement and the walls to the staircase - though most obviously on the landing) may have originated in phase 1, since the northern wall of the staircase was the limit of the remaining part of the surface building and there would have been severe disturbance when the northern end was demolished. This is not capable of proof of course - not least since we do not know exactly when that demolition occurred in the first place.

The northern end could possibly be mitigated by setting a deep land drain immediately adjacent to the staircase wall and pressure injecting grout into the line of weakness where the brickwork (which may or may not actually front a concrete wall) meets the roof slab of the basement - but grouting on its own without a drain would simply force the water to find another path along that line of weakness - as it can be seen to be doing in a small way already. Again, the solution is not cheap - although possibly easier than that for the southern end.

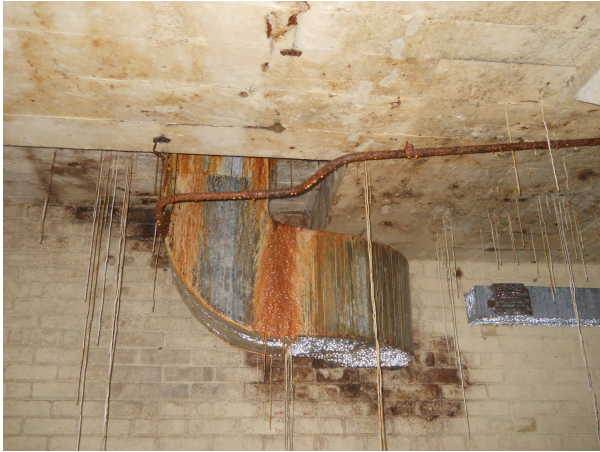
Image 6 (Photo: Bill Ridgeway)

Water also ingresses into the (large) room adjacent to the Air Conditioning Plant Room (LR133) (**Image 6**). Water flows within the air ducting from here into the Air Conditioning Plant Room (LR134) and into the heat exchanger (**Image 7**) from which it overflows on to the floor resulting in permanent flooding of this room, the adjacent ground dewatering wellpoint room (LR136) (**Image 8**) and the adjacent spine corridor. Duckboards have been placed in the Air Conditioning Plant Room (LR133) and in the adjacent corridor (but not the ground dewatering wellpoint room (LR136) (**Image 9**) and the spine corridor (LR164) (**Image 10**).

The leakage over the air-con room is almost certainly the result of the demolition contractors - or the builders subsequently - failing to properly seal the ducts that penetrate the roof slab of the basement at that point. As we now know, both the diesel intake pipe and at least two air ducts went through the slab at this point - there is no actual internal communication between the air passing through the air conditioning plant and the air circulation plant across the corridor - this must all have happened in the surface building. There are some indications that the primary air inlet to the air conditioning plant was outside the surface building - certainly the intake duct is outside the putative line of that building and coincides with an external rectangular object visible on the aerial images.

6) Solutions - are expensive! Without checking my drawings and images I'm not sure if the southern ducts are under a house or in the front gardens. In either case, there is no real possibility of access to repair the seals, leaving the only real alternative of grout injection - which carries with it the risk of heave under the houses and consequent damage - if done properly it would do the trick, but it is not cheap!

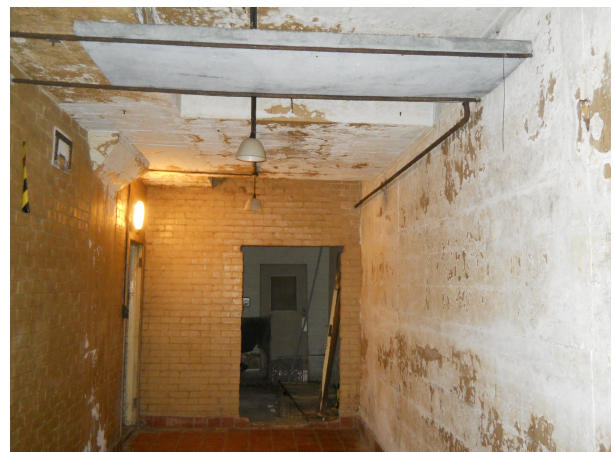
Image 11 (Photo: Bill Ridgeway)

There is a fourth area from which water may have ingressed (but not since 2000). A horizontal conduit runs along the outside wall between the battery room (LR101) (**Image 11**) (collecting leakage from the ceiling presumably). This runs through intervening rooms (LR103) (**Image 12**), LR104 (**Image 13**) and LR107 (**Image 14 and Image 15**) until it meets five drainage holes. From here a white plastic pipe runs around the room, through a narrow room (LR158) across the corridor (LR151), into the opposite room (LR129) and down until it ends up in one (possibly the northern) sump. It is not known why or when this was installed.
