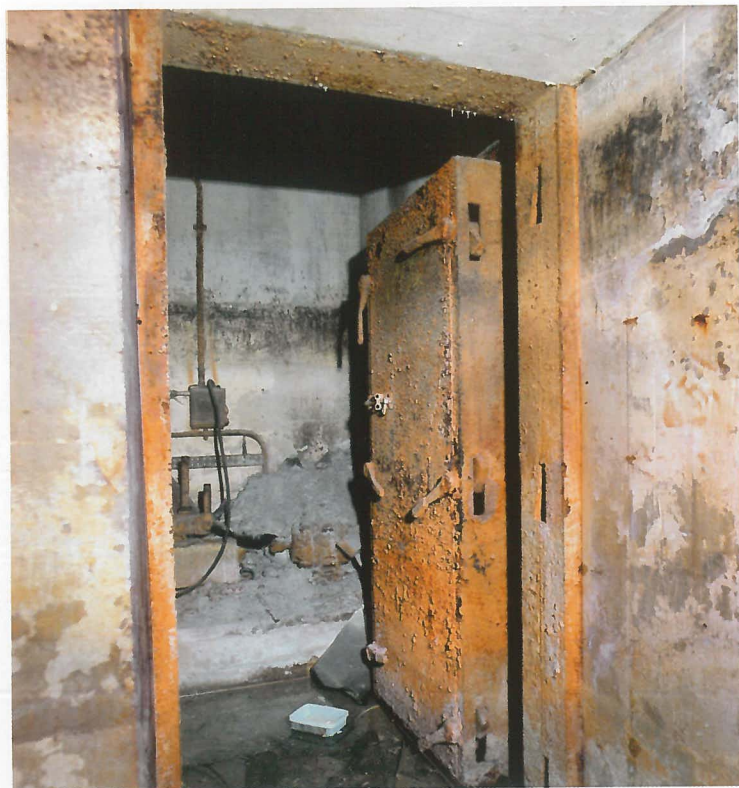
*Above left:* The blast door at the bottom of the western spiral staircase. The corrosion is a consequence of the lower floor having been under water for a prolonged period.

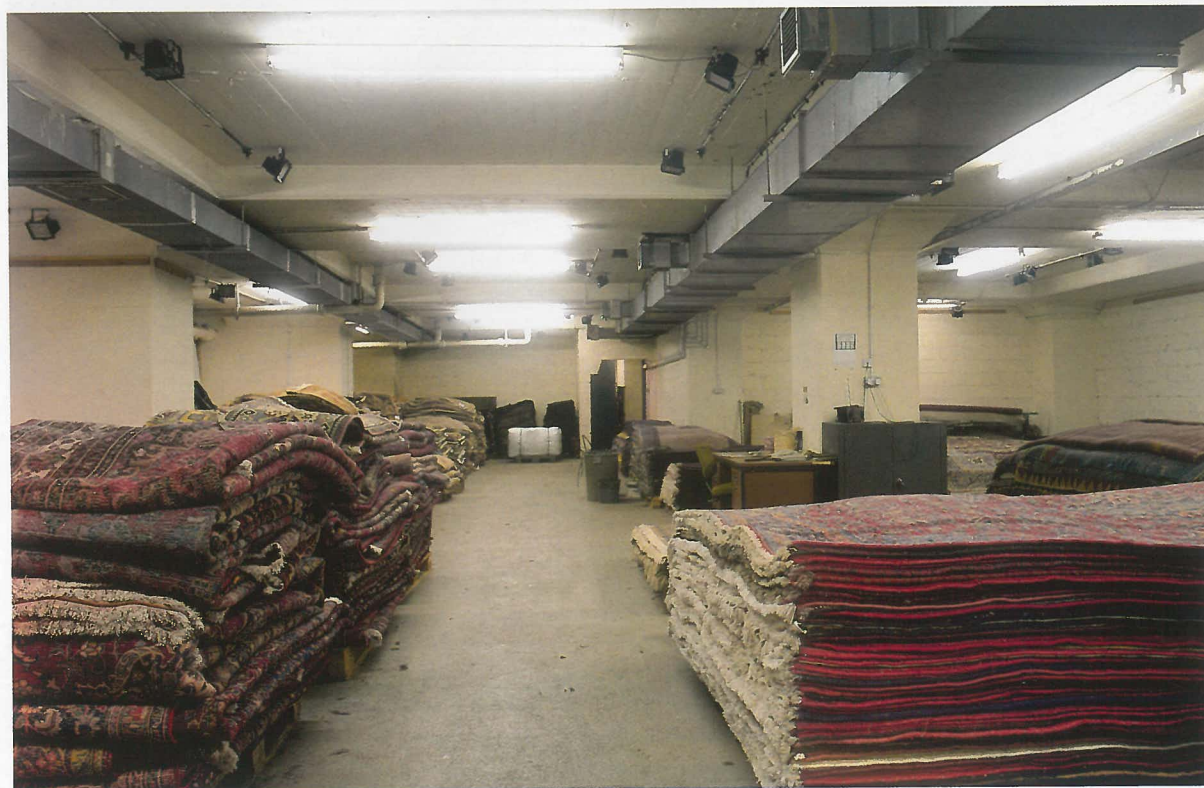
*Left:* The upper floor of the bunker, in use as a carpet warehouse. When this photograph was taken the lower floor was submerged in stagnant seepage water.
