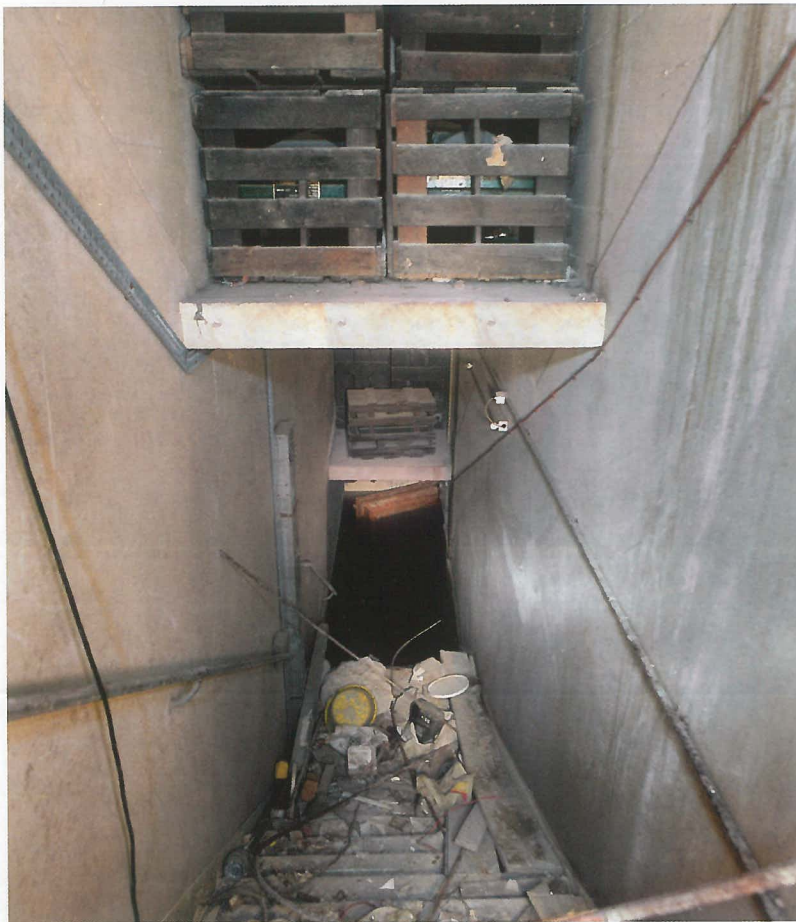
*Above:* Looking down the main western stairs from the upper to the lower floor of the bunker. This photograph was taken in 2001 before the lower floor was pumped dry. The water can be seen just below the top of the blast door. Crates of air filters can be seen on the concrete shelf above the stairs.

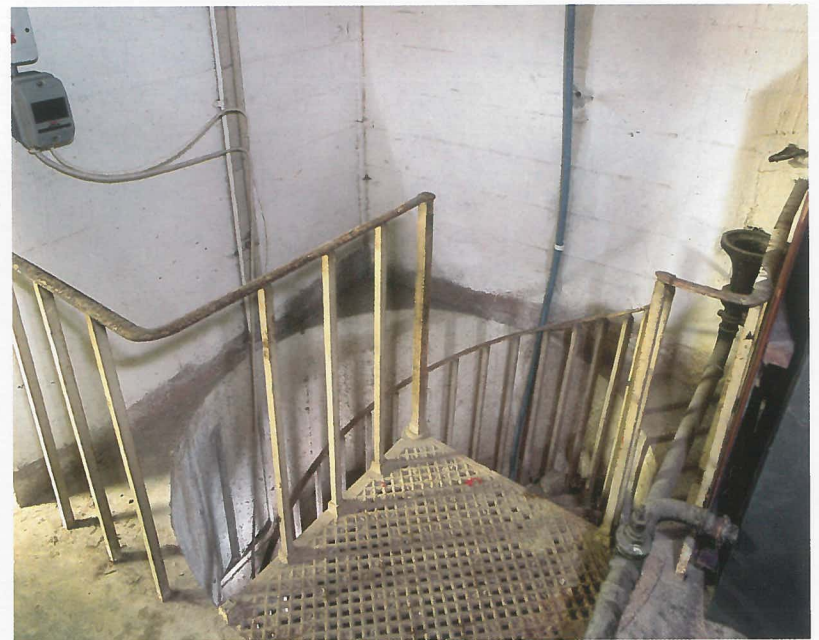
*Above right:* Two spiral staircases provided emergency exit routes from the lower floor of the bunker. This view of the upper landing of the south staircase illustrates the thickness of the concrete floor slab between the upper and lower levels.

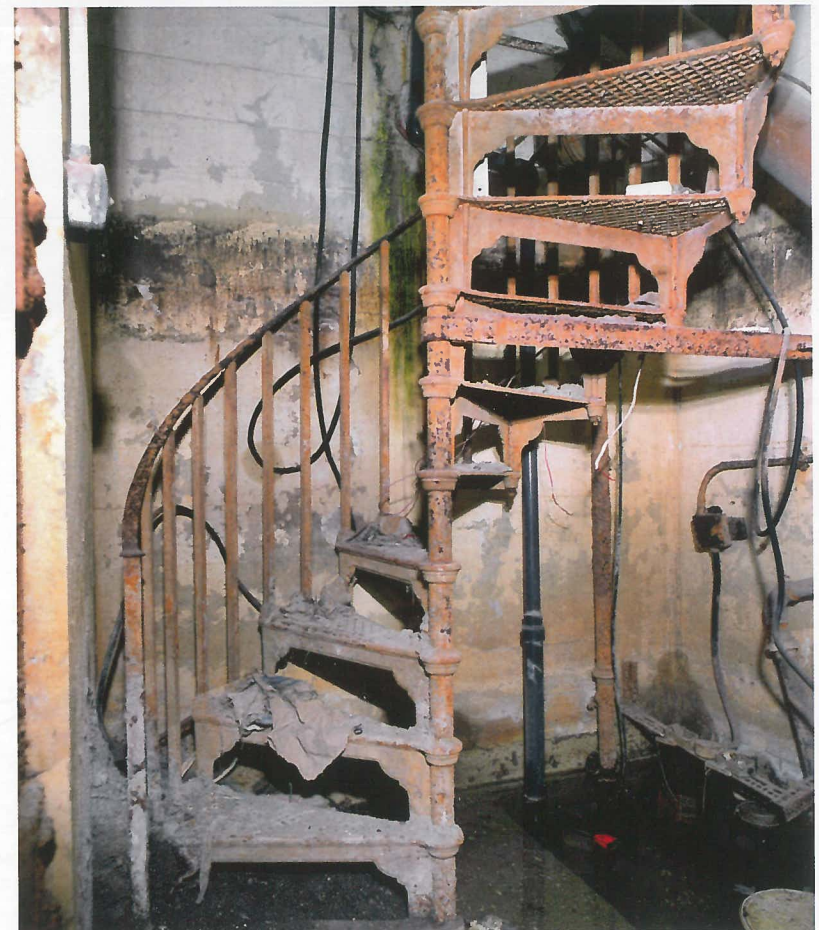
*Below right:* The bottom of the ornate, cast-iron spiral staircase in the western emergency exit shaft.
